AOPA BARON FUEL CELLS

LEAKING DURING AIRVENTURE 2024

KURT HARTWIG | EAGLE FUEL CELLS | AUGUST 22, 2024

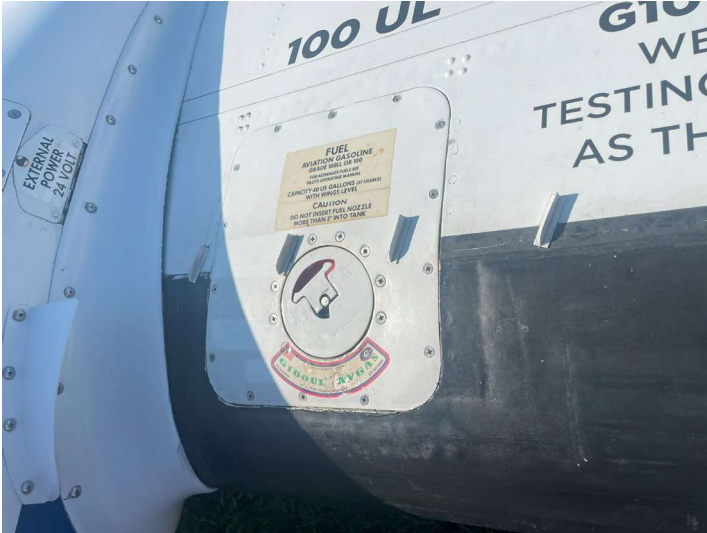
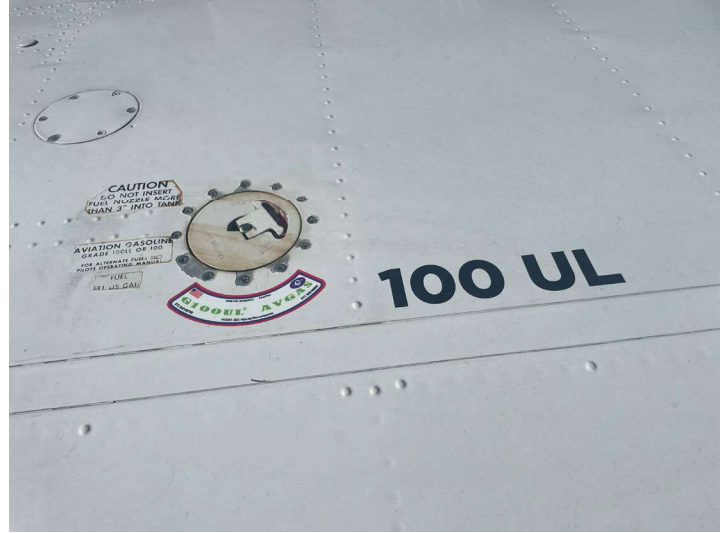
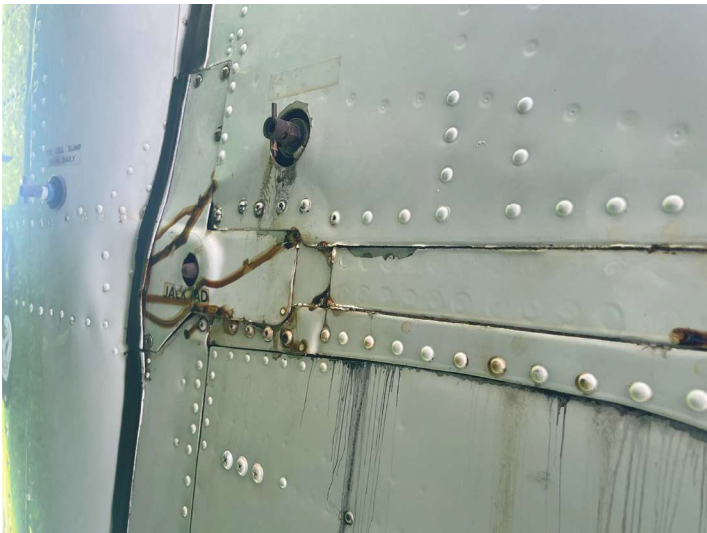
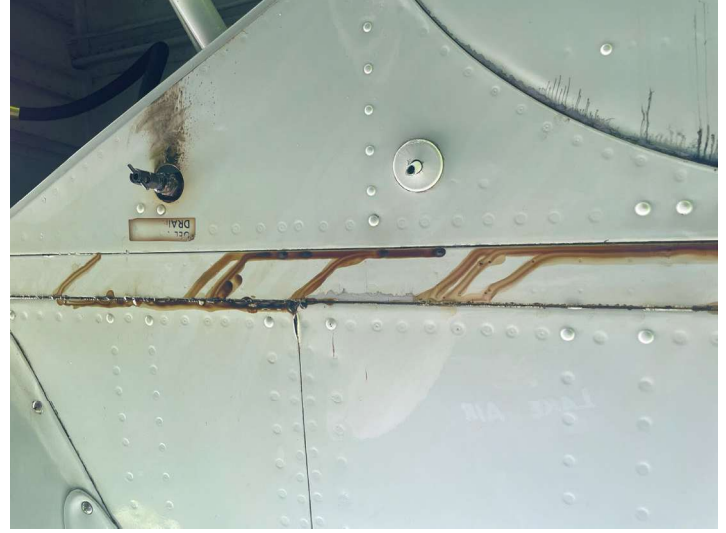
On the way to AirVenture, it is my understanding the aircraft made it's final fuel stop in Illinois where G100UL was available. It was then flown into AirVenture on Saturday and parked at the AOPA pavilion. About 10-15 gallons of fuel per side was used during the flight. On Monday, dark stains had formed along the left forward spar down to the low point on the wing and then leaving a brown stain in the grass. The following are photos taken Thursday July 25, 2024.

The amount of staining and residue found is normally seen when there is a significant leak that floods the fuel cell cavity floor and removes the tape adhesive leaving a gooey mess. Small leaks will first give a fuel smell and possibly a small stain. A significant leak would cause a significant stain and a drip. If there was a serious leak the bottom of the wing would be covered in stain and goo with fuel dripping. By Tuesday there was no visible dripping only residue. Initially I felt gaskets could be the cause. I supplied AOPA's mechanic Carlo with a fuel set of gaskets and the torque values. Upon inspection he did not find any staining or loose bolts. Given the now stable condition the aircraft was left on display.

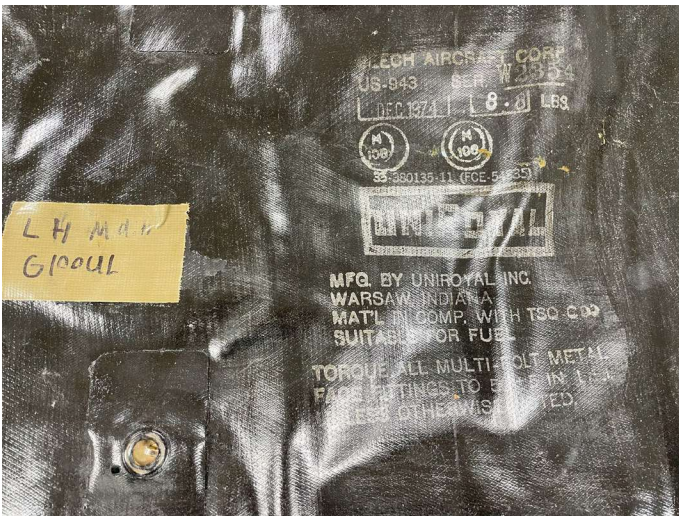
We noted the brownish color.

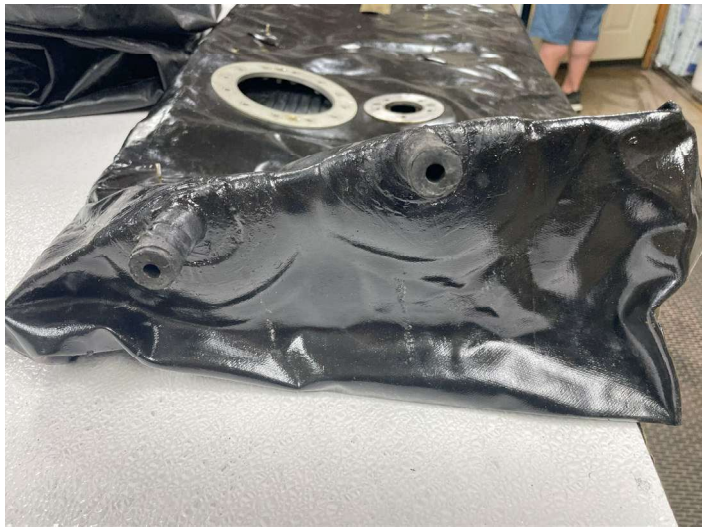
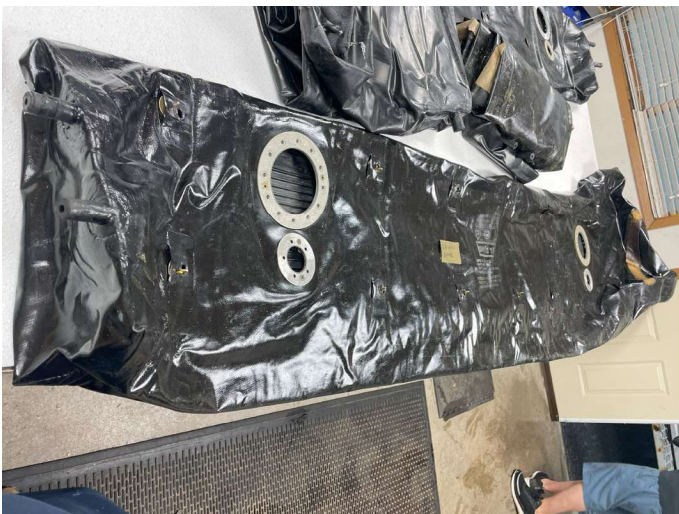
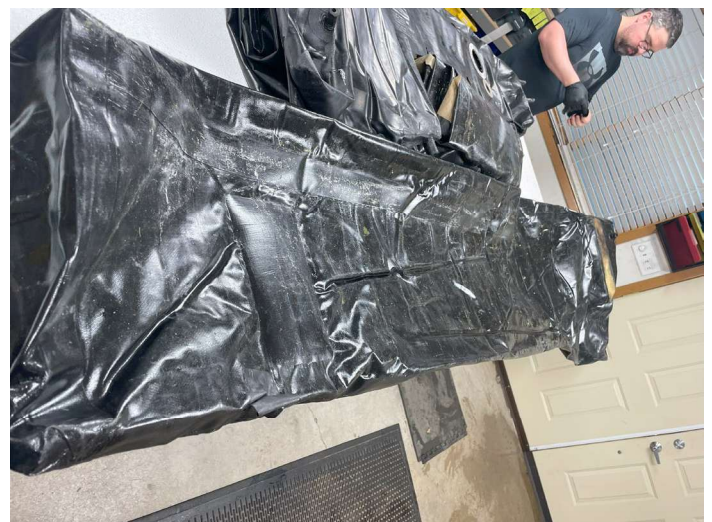
The top and bottom of the left main had the normal amount of sticky residue for a leaking cell but also seemed oily.

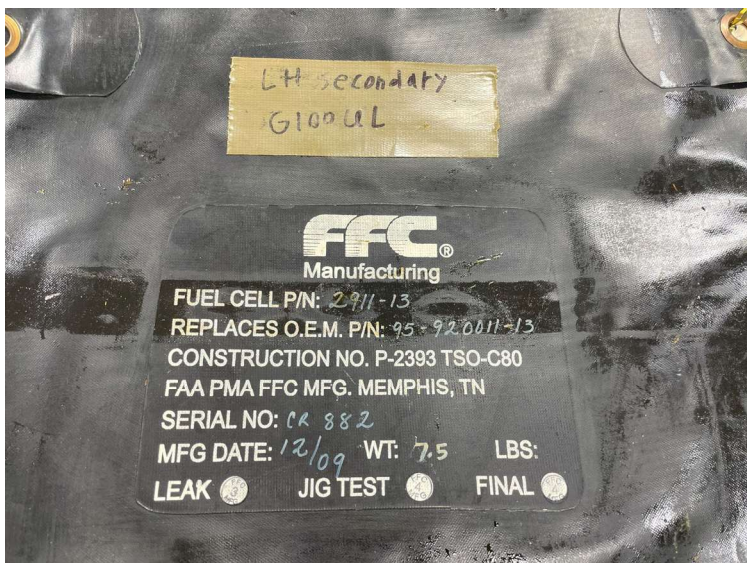
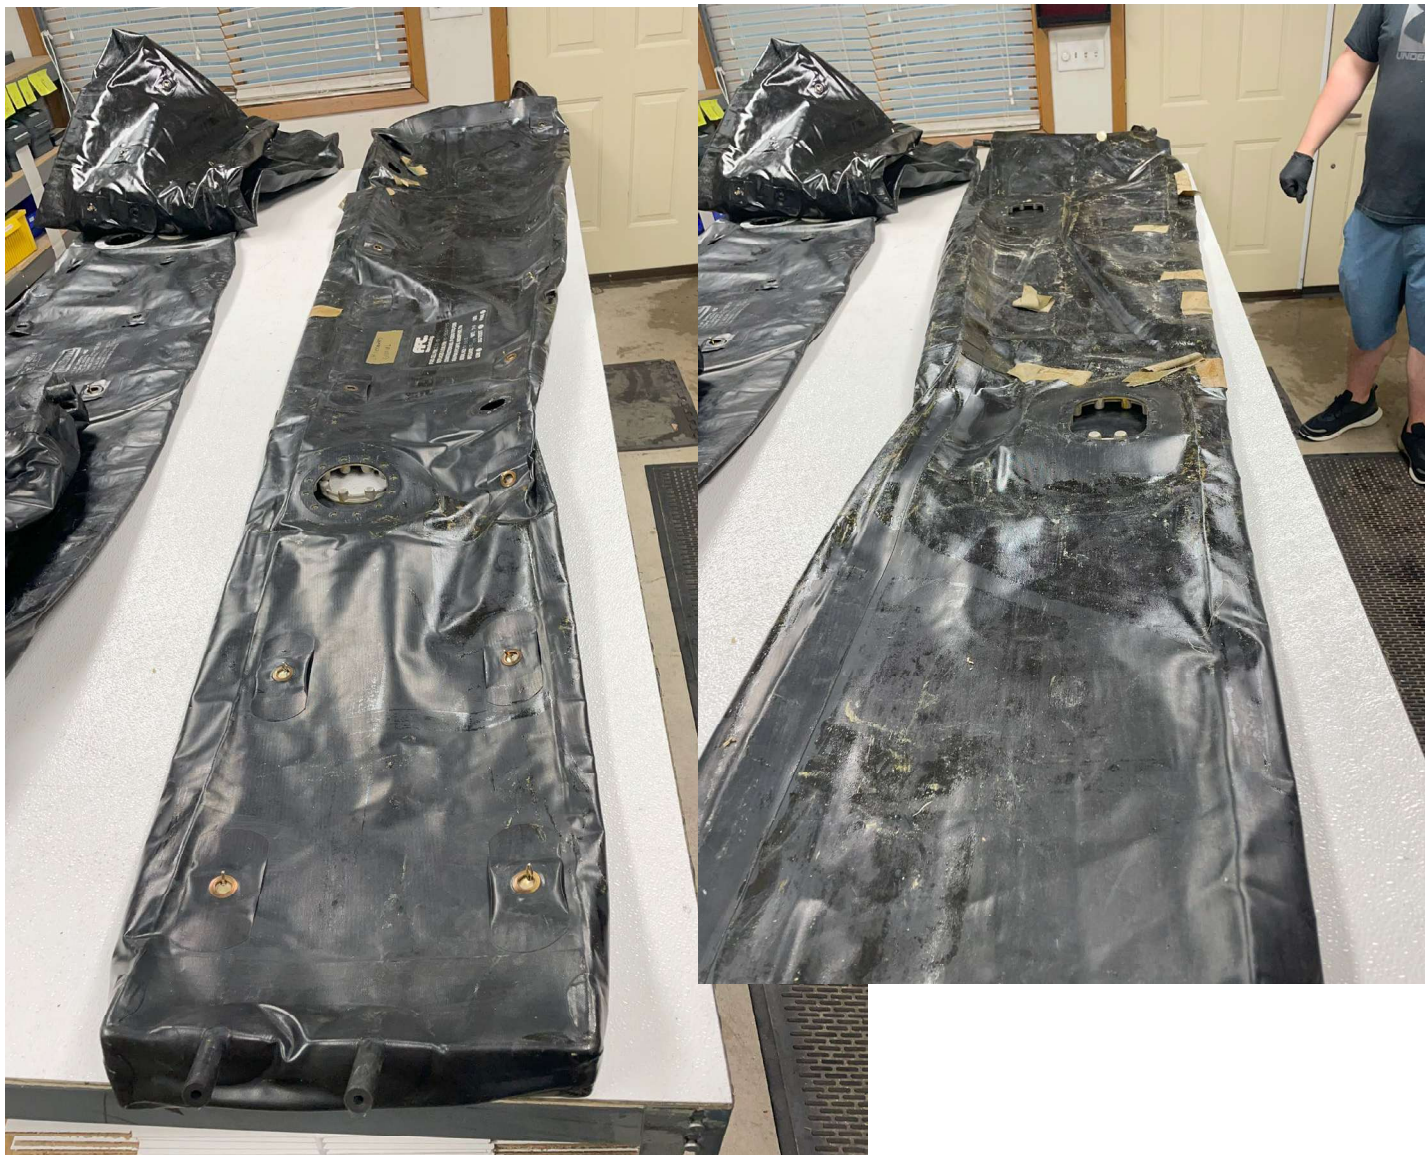
Curiously the top and bottom of the left aux was just as sticky as the left main which would normally indicate a significant leak in the aux cell. Note the detached cavity tape stuck to both top and bottom.

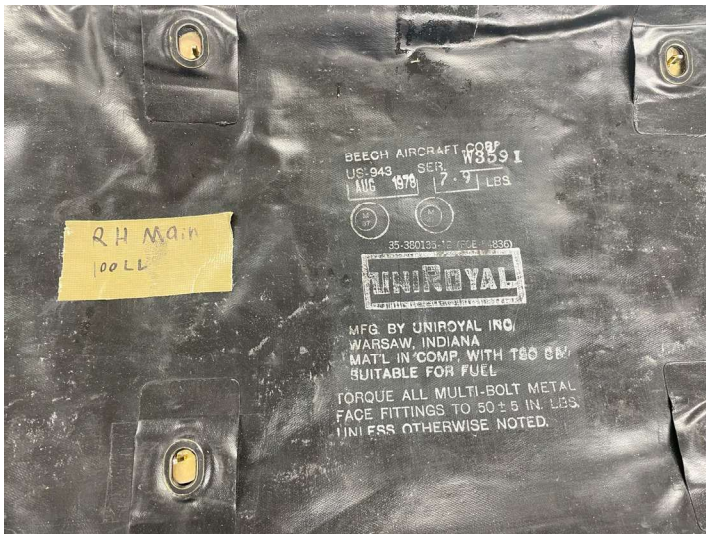
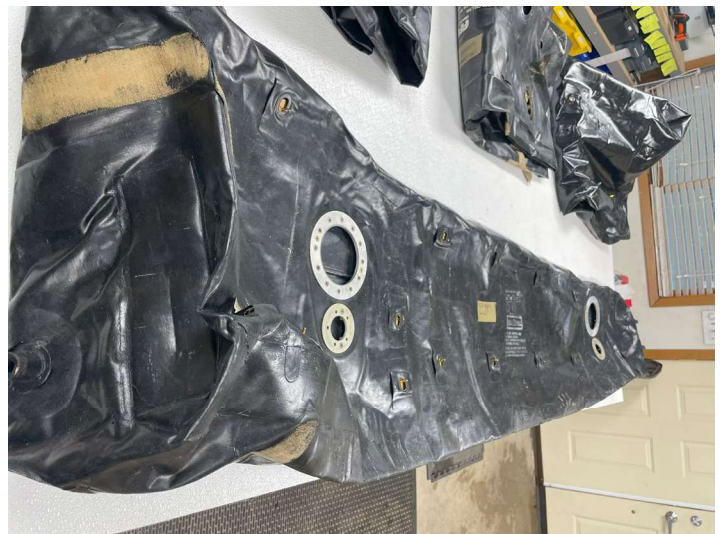
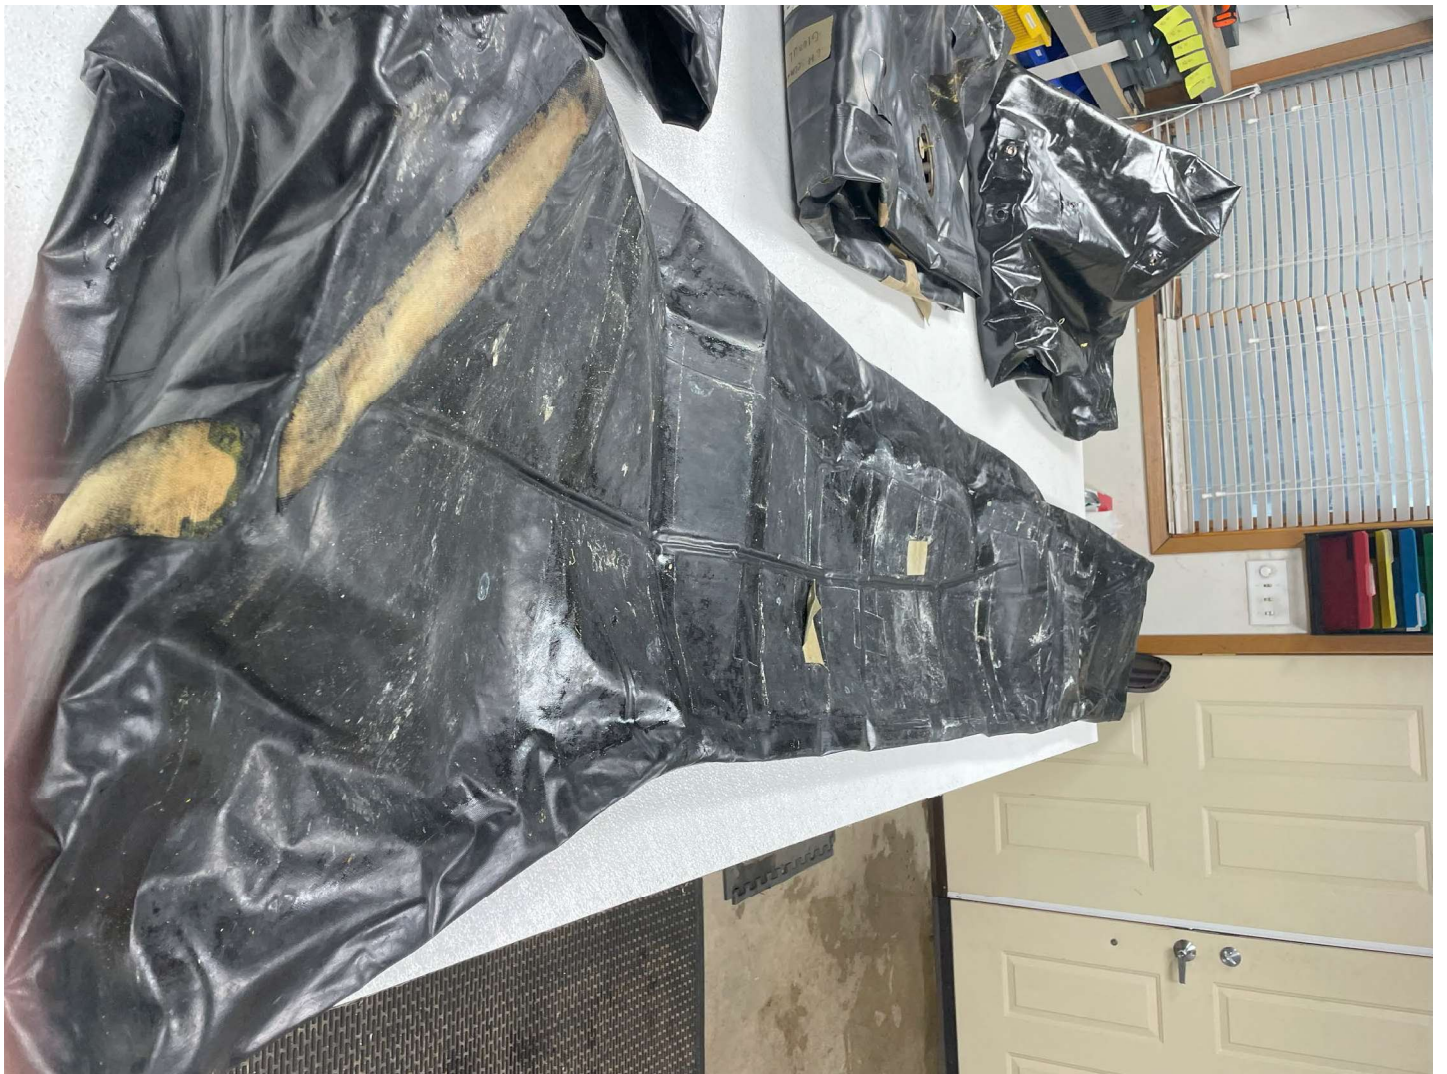
The bottom of the right main had moderate tape residue indicating a small leak.

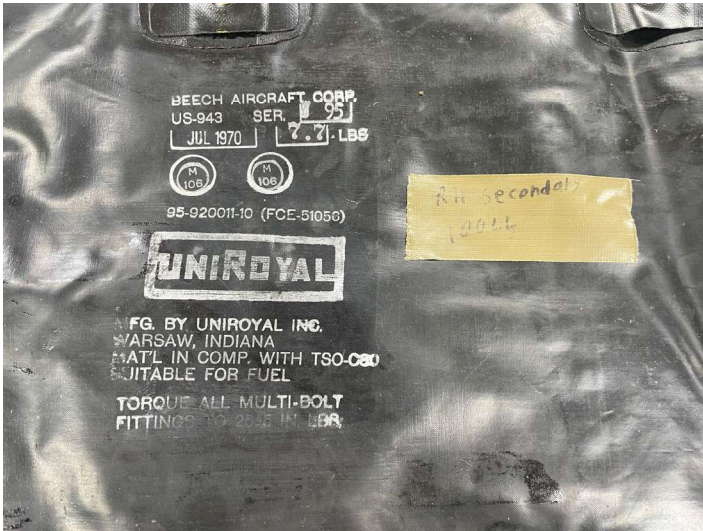
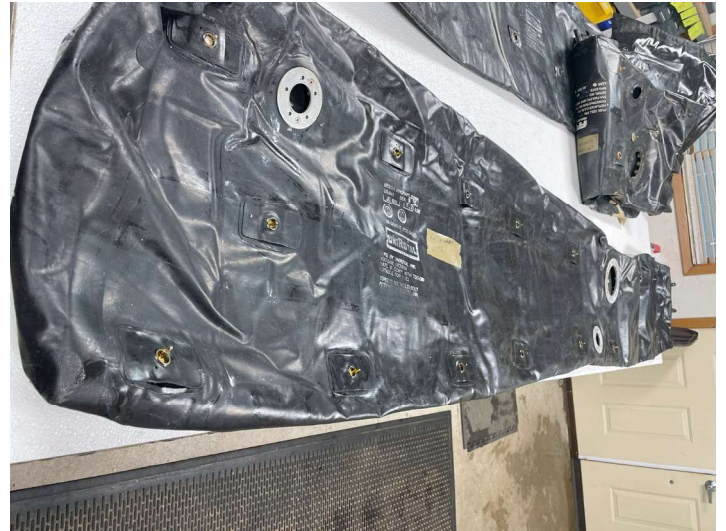
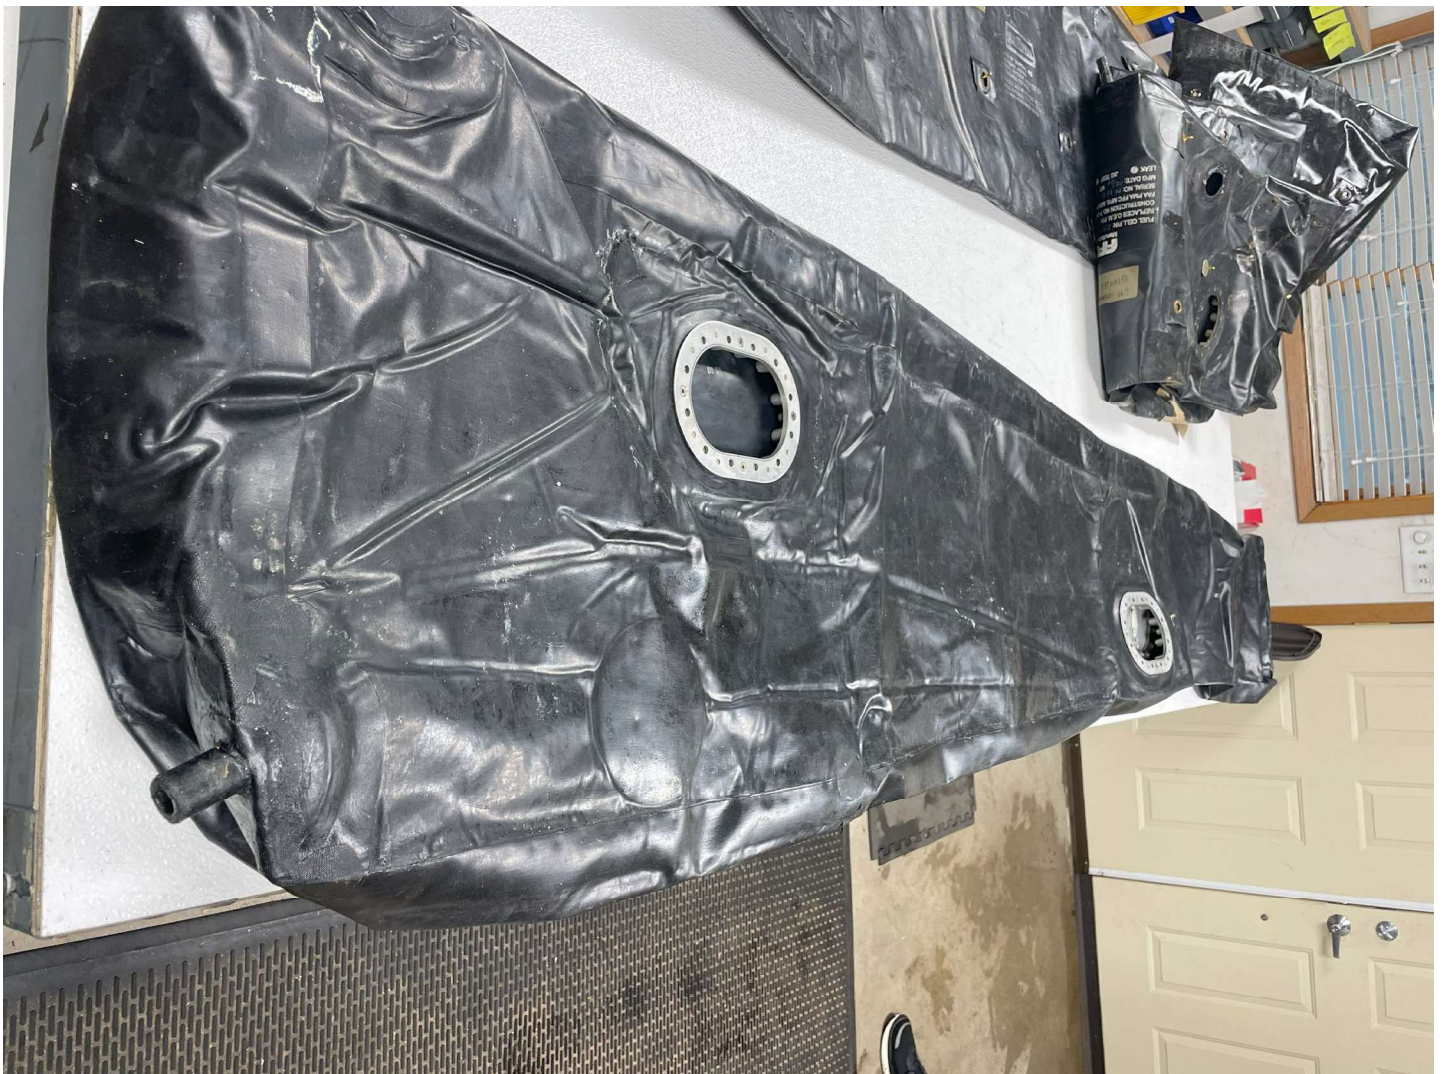
No tape residue on the right aux would indicate a non-leaking cell.

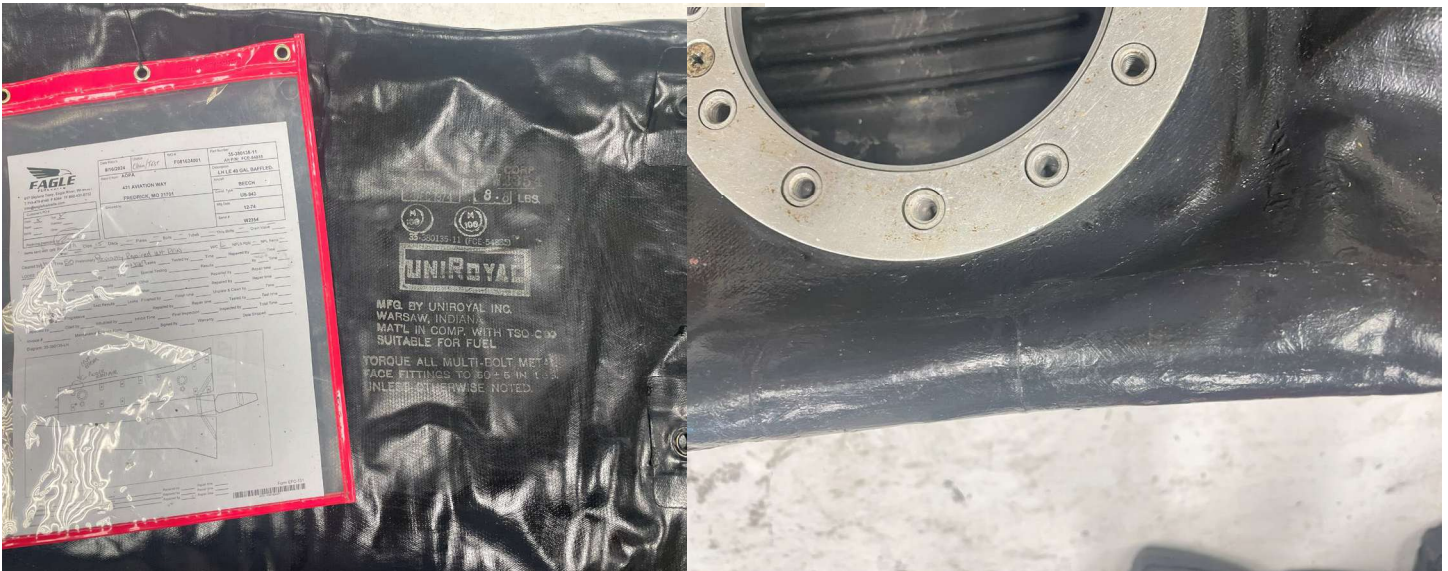
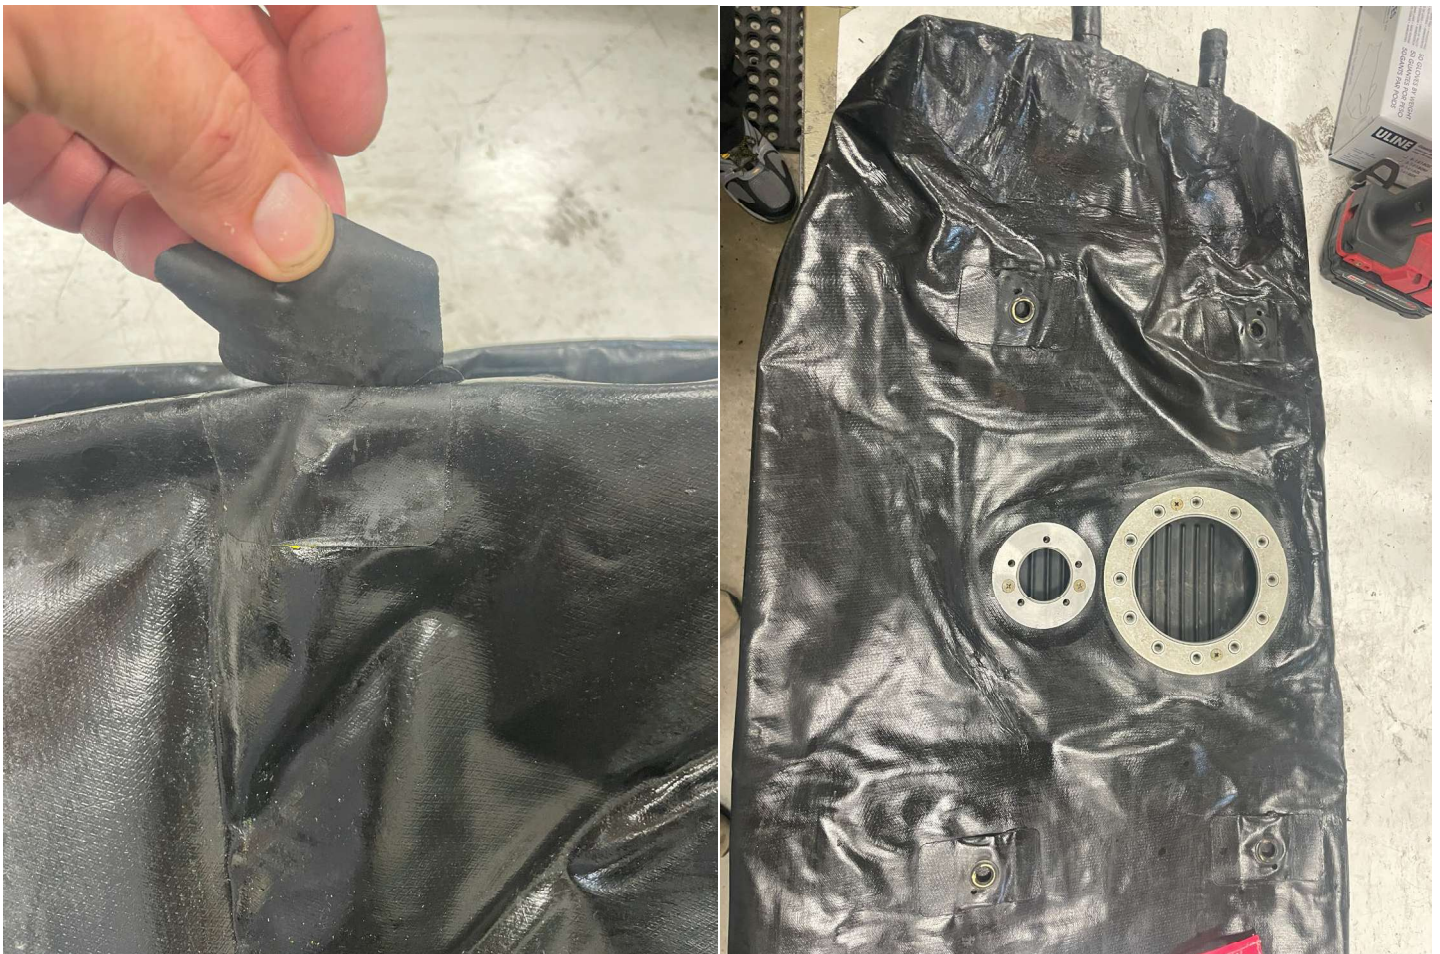
Photos of the previously repaired area forward of the filler neck wrapping around the leading edge on the left main.

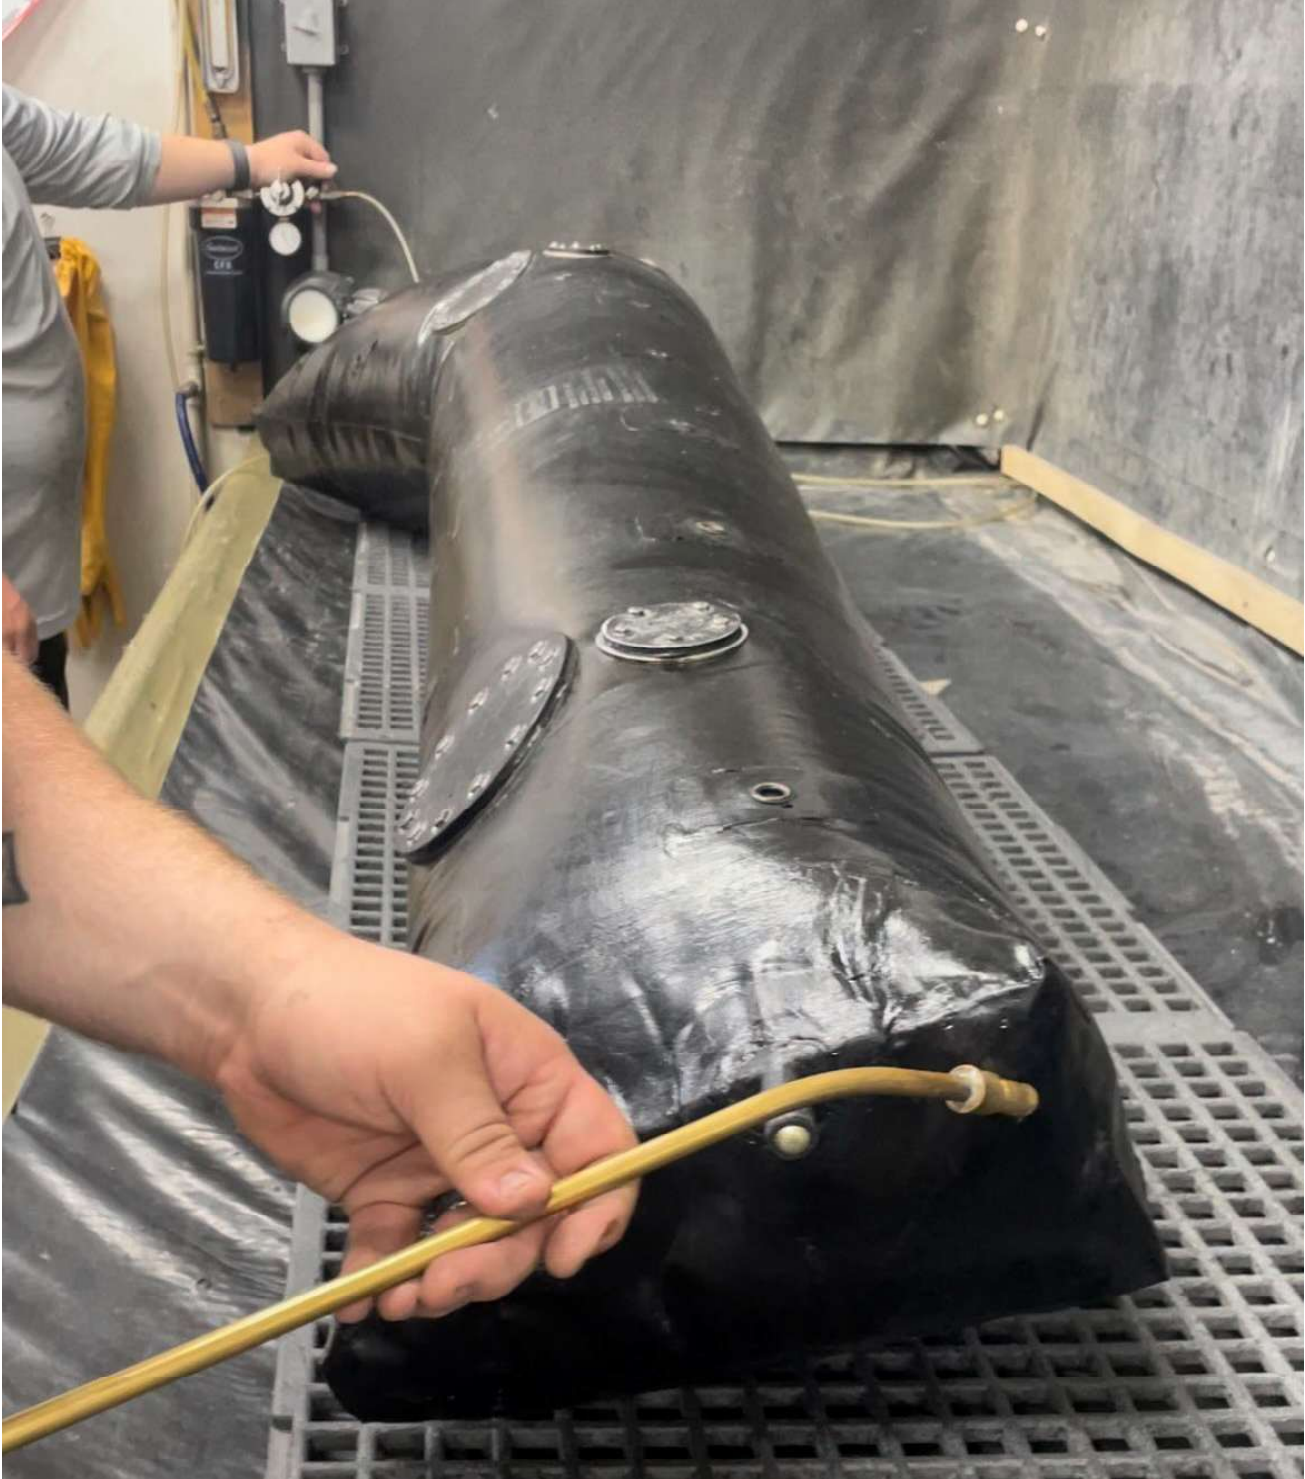
The pressure test indicated that the two main cells were leaking, and the auxiliaries were not. The right main in I00LL had nine very small leaks. The left main in G100UL had fifteen small leaks and a loose repair. The majority of all leaks were on the upper surfaces. None of the leaks were significant; most of which would evaporate in summer temperatures.

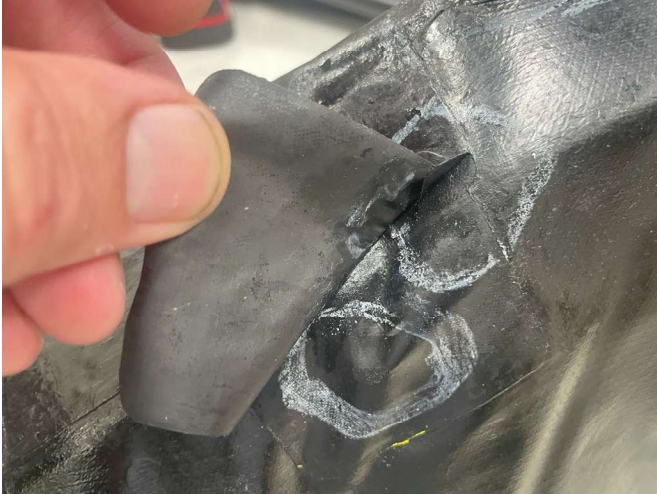
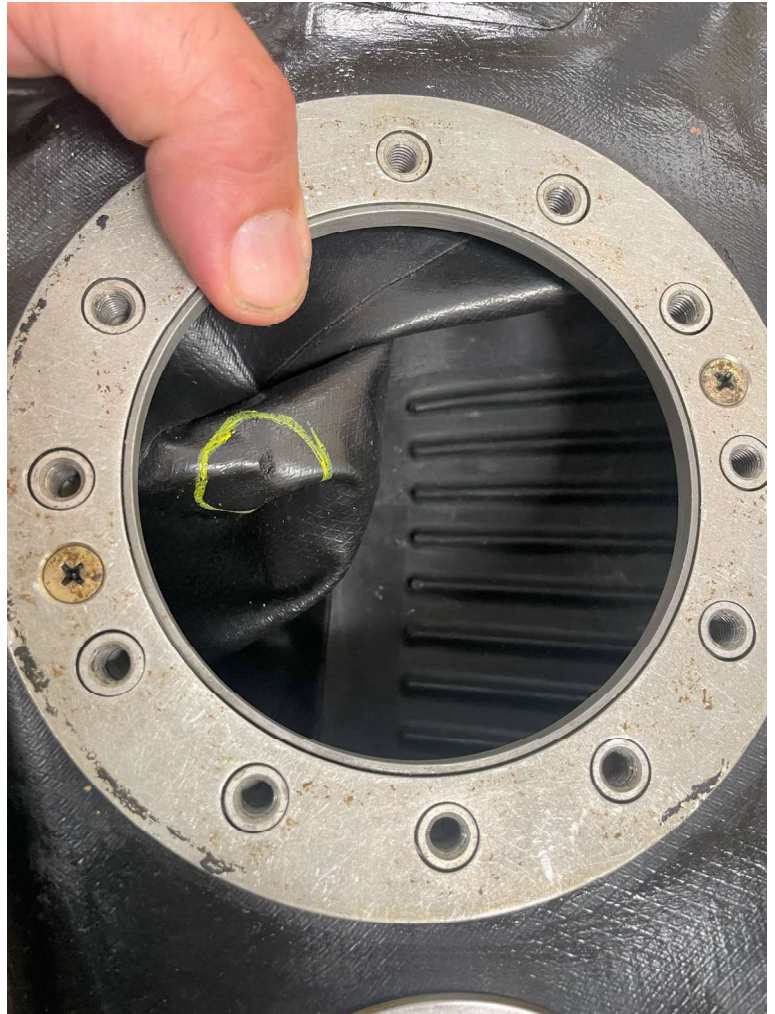
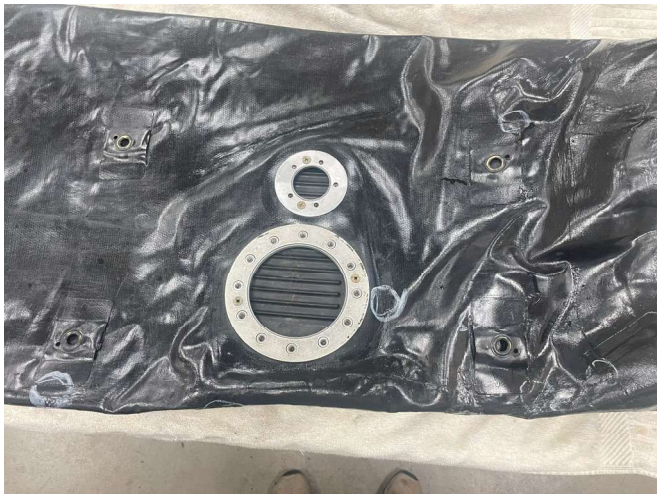
There were no cuts found on any of the cells. However, there was a small bit of missing rubber internally just outboard and forward of the striker pad below the filler neck in the left main. Directly on the outside of this area was a repair that was loose. Also the weather checking, that was documented and coated sixteen months prior, was pronounced again and this time it was leaking both on the left main as well as the right. This is the main reason for all the small leaks on both.

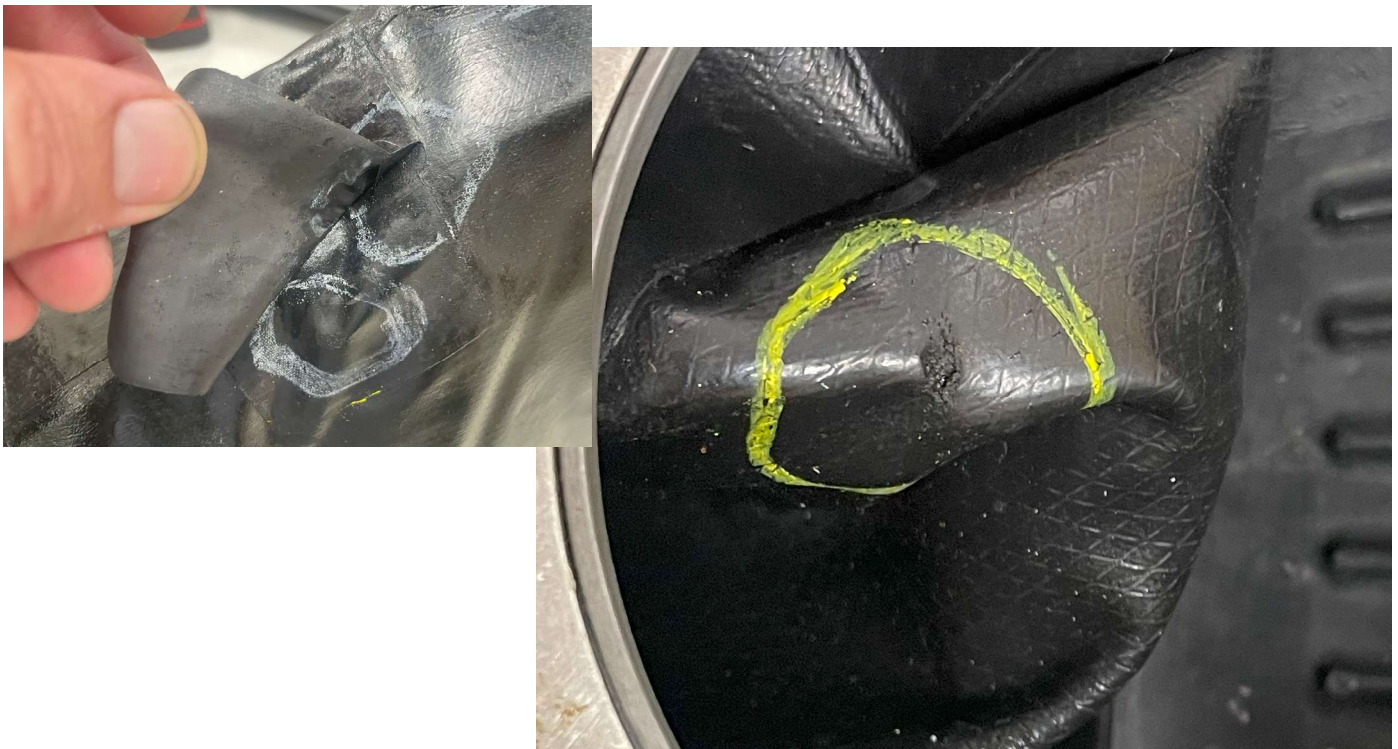
- The left main cell had a loose exterior patch and a scuff like divot directly inside the cell below the filler.
