AOPA BARON FUEL CELLS

LEAKING DURING AIRVENTURE 2024

KURT HARTWIG | EAGLE FUEL CELLS | AUGUST 22, 2024

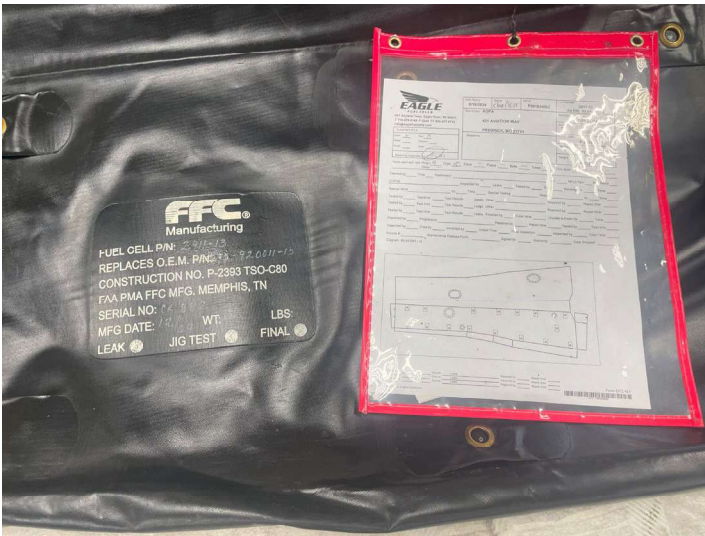
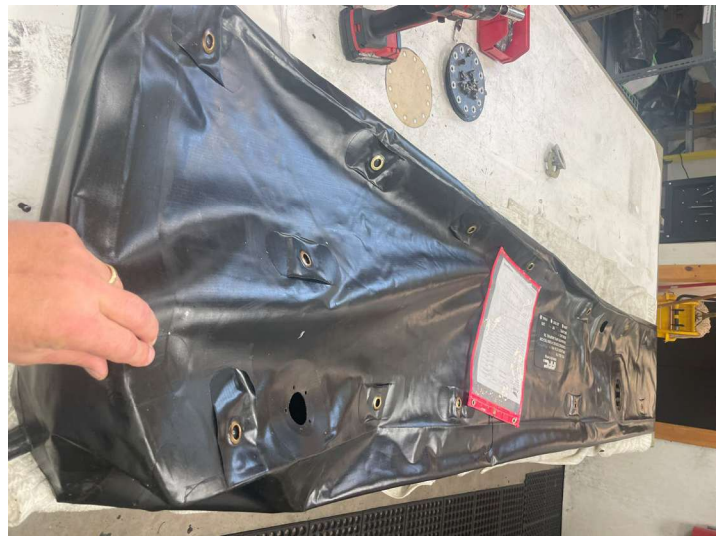
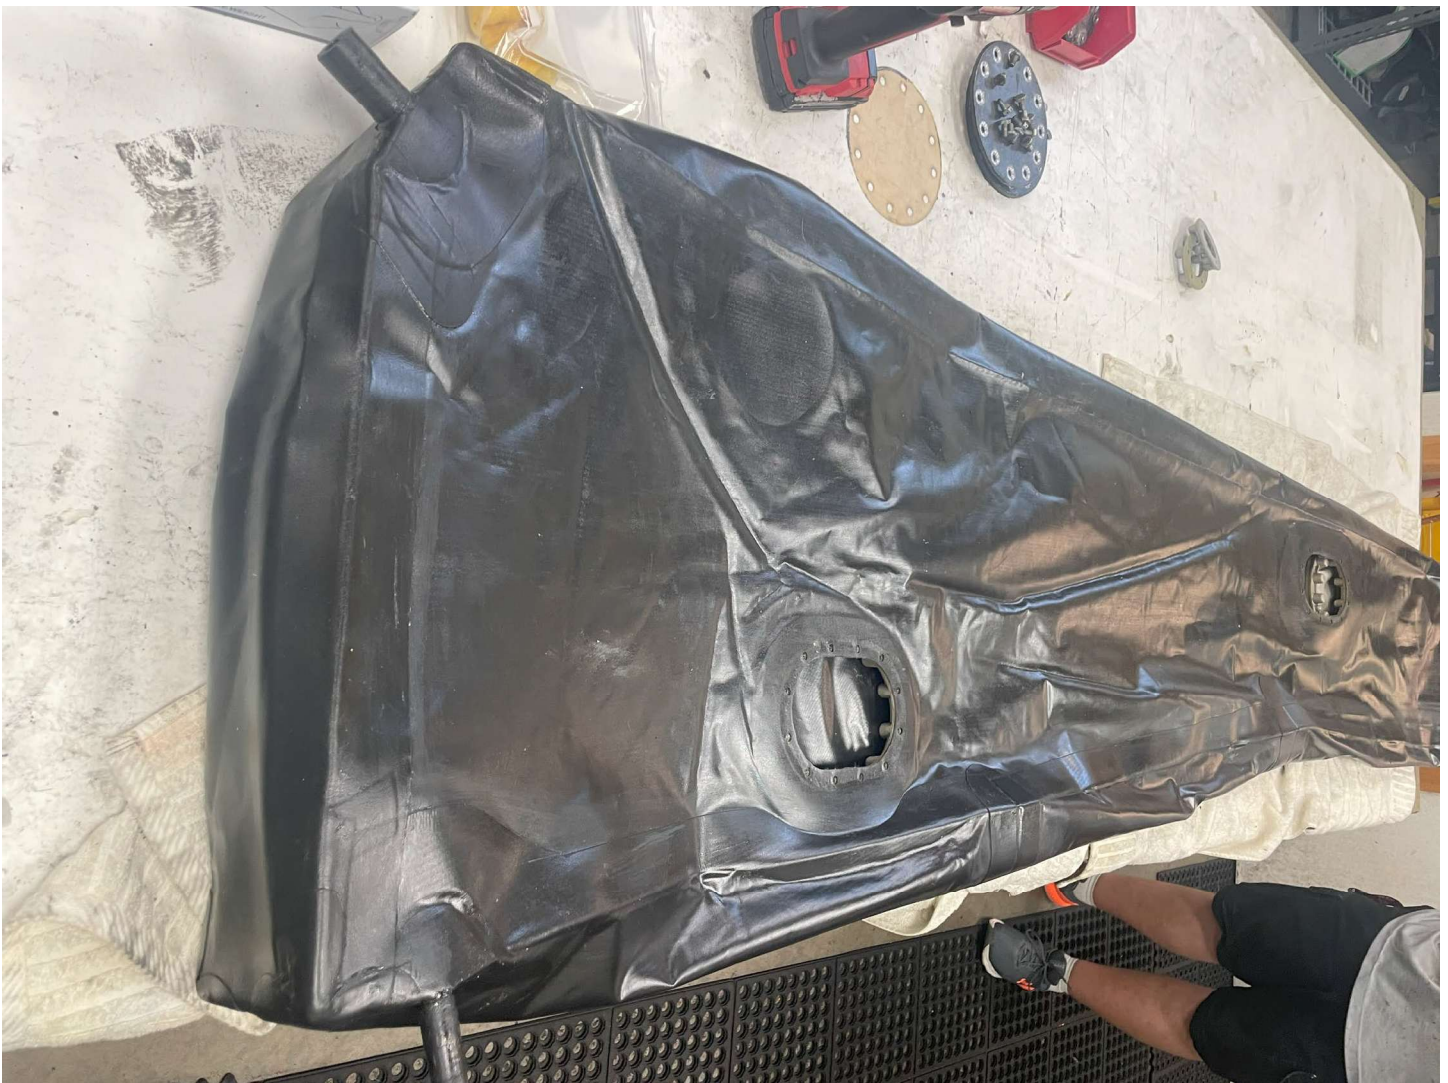
Photos of the previously repaired area forward of the filler neck wrapping around the leading edge on the left main.

There were no cuts found on any of the cells. However, there was a small bit of missing rubber internally just outboard and forward of the striker pad below the filler neck in the left main. Directly on the outside of this area was a repair that was loose. Also the weather checking, that was documented and coated sixteen months prior, was pronounced again and this time it was leaking both on the left main as well as the right. This is the main reason for all the small leaks on both.

- The left main cell had a loose exterior patch and a scuff like divot directly inside the cell below the filler.

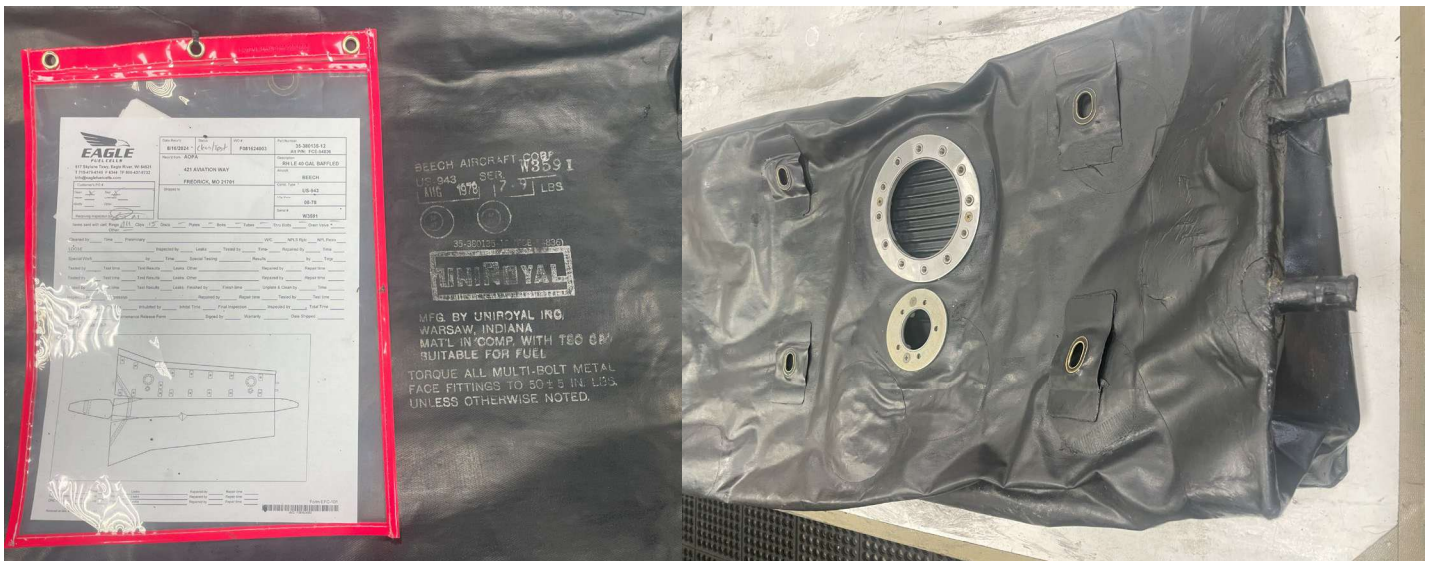
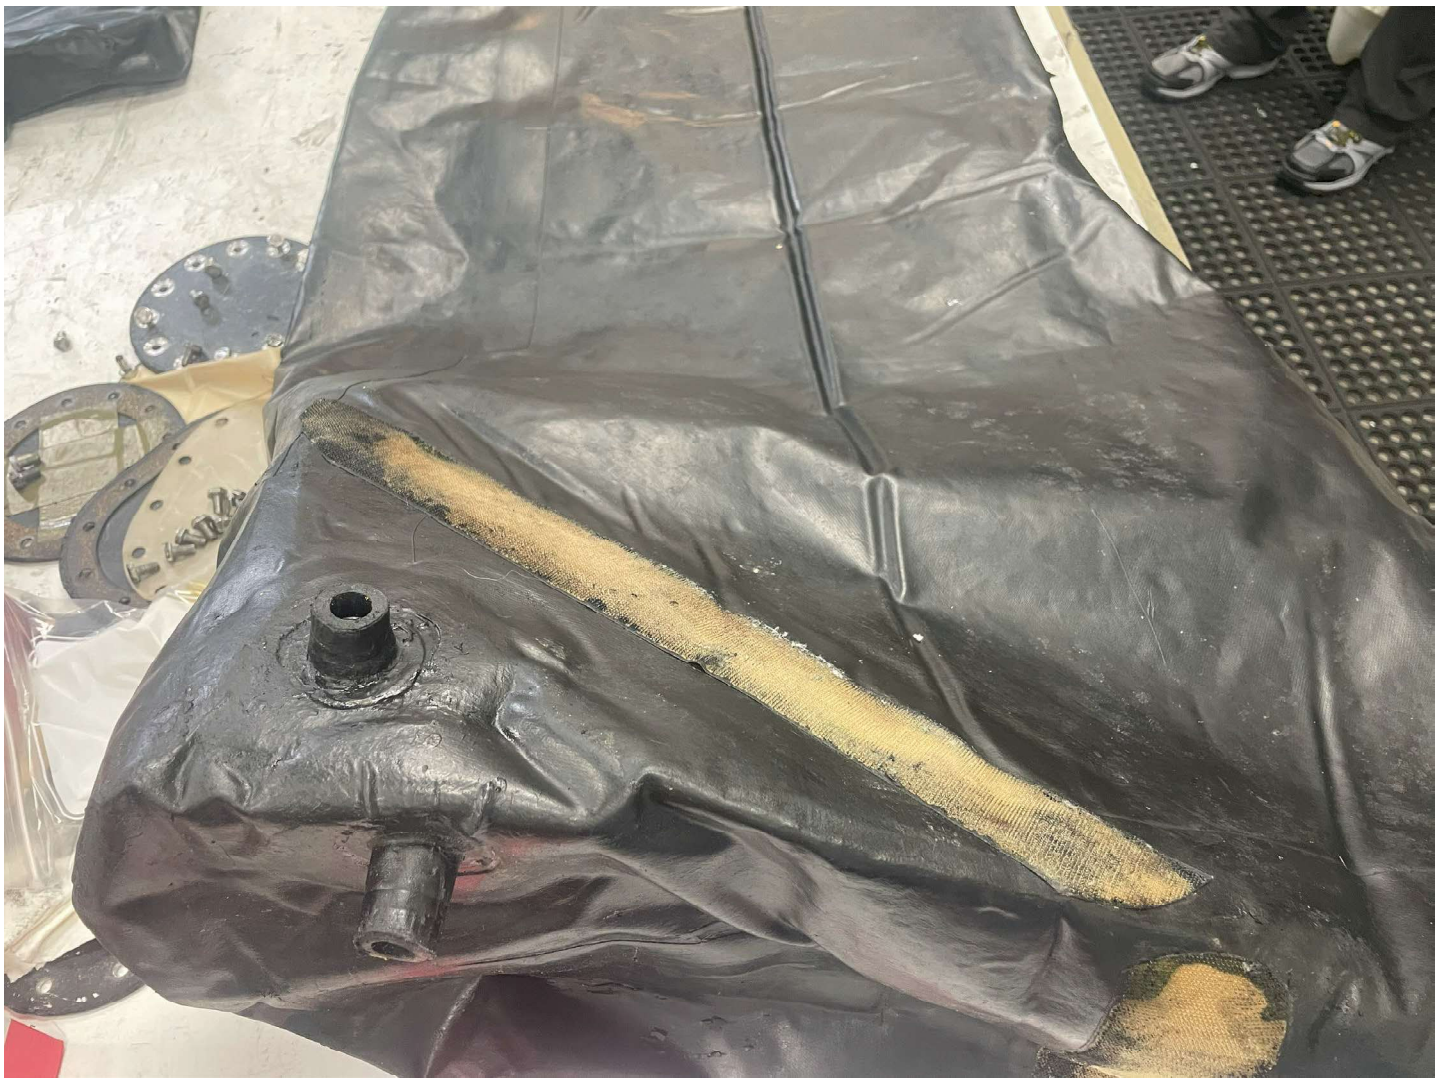
Cleaned lefthand aux.

Given the areas of stain and stickiness observed during the receiving inspection, we expected the lefthand auxiliary cell to leak as well. However, the stickiness could have been caused by seepage into that cavity. The stickiness of the leaking main cells was in keeping with the number of leaks found. There is no doubt the patch may have been partially loose given its location however, the extent of the detachment in situ is in question. The removal and subsequent handling would have further separated the repair. The important question is why the repair began to detach. It may be possible that the missing internal rubber may have allowed the solvents in the fuel to penetrate the fabric and the exterior rubber coating and then getting beneath the external repair. This is most likely the reason given how the repairs are bonded. The installation and removal process is very stressful on the rubber since the cells must be rolled up tight in order to insert them through the small access panels. Generally, the older the rubber the stiffer the cell, so the actual number and size of the leaks in situ is almost impossible to determine as the removal process usually does create more leaks and work. Keep in mind the two leaking main cells are forty six and fifty years old.

- On the left aux, several bolts on the lower access plates and screws on a transmitter were under torque.
- The left and right main cells both had a number of minor leaks, and the left and right aux cells did not.

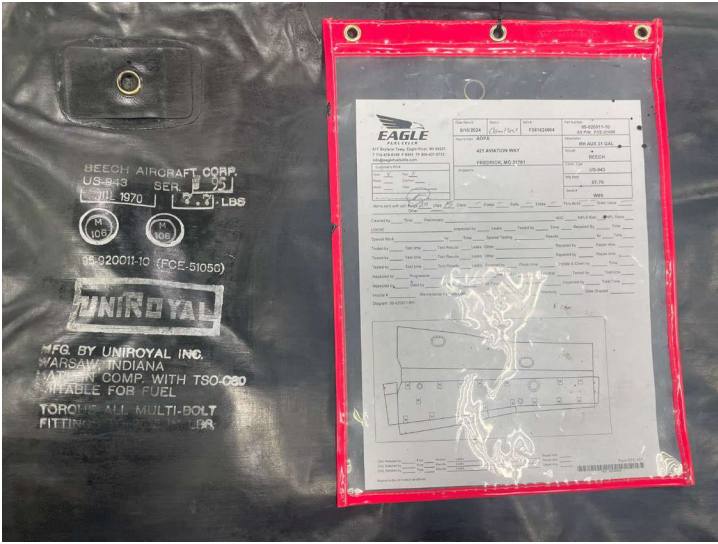
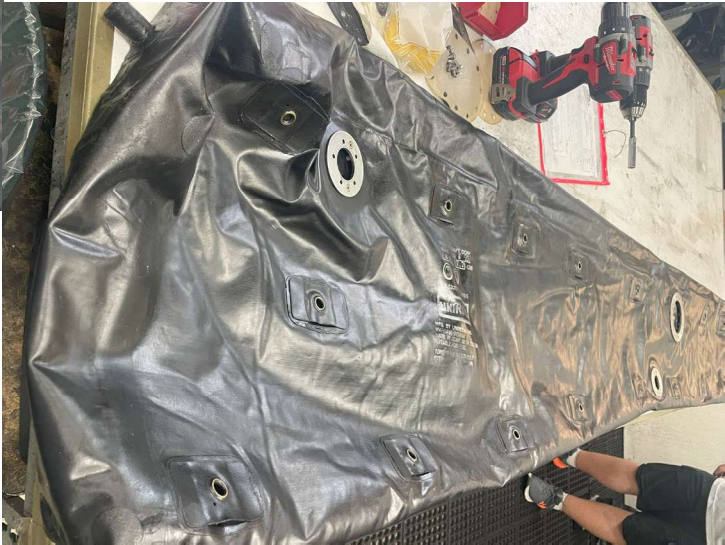
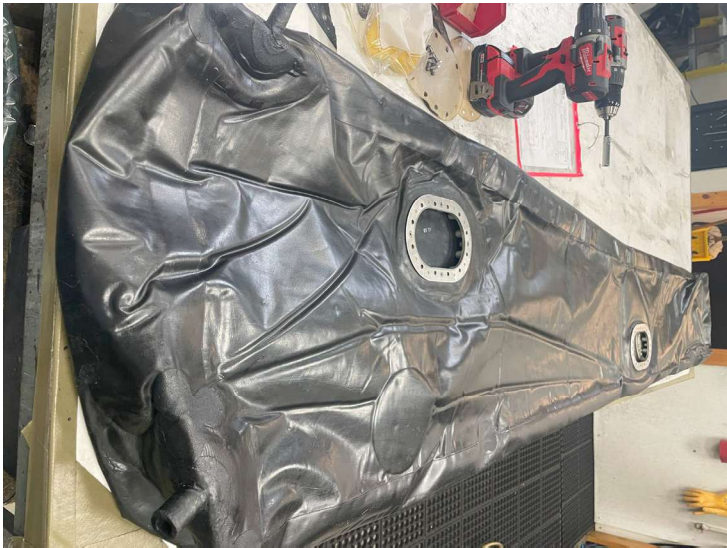
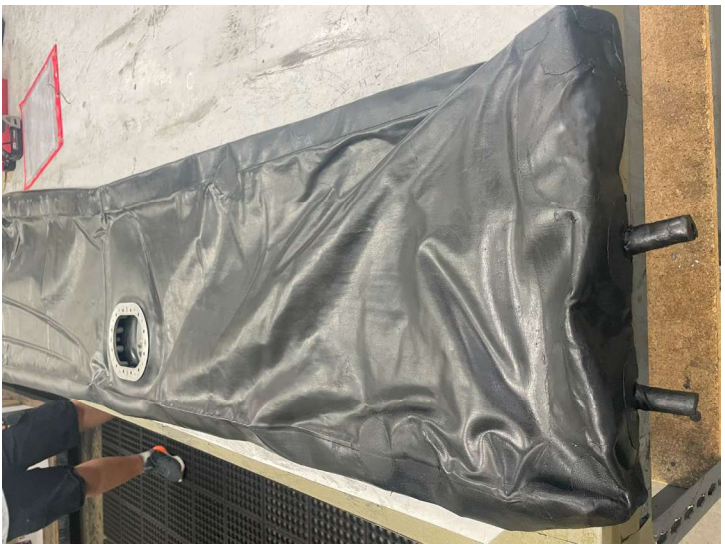
Cleaned right main

The pressure test indicated that the two main cells were leaking, and the auxiliaries were not. The right main in I00LL had nine very small leaks. The left main in G100UL had fifteen small leaks and a loose repair. The majority of all leaks were on the upper surfaces. None of the leaks were significant; most of which would evaporate in summer temperatures.
